[Back To Article](#)**UNEVEN REAR TIRE WEAR, CORRECTION OF EXCESSIVE NEGATIVE CAMBER****TECHNICAL SERVICE BULLETIN**

Reference Number(s): TJ 15309, Date of Issue: April 23, 2012  
 VOLVO: 2007-2012 C30; 2006-2012 C70; 2004-2012 S40, V50  
 SECTION: Control Arm  
 GROUP: 6526  
 NO.: US15309.4.1 en-GB  
 Related Ref. Number(s): VIDA, VSTG, RTJ TJ15309

## **TJ INSTRUCTION - UNEVEN REAR TIRE WEAR, CORRECTION OF EXCESSIVE NEGATIVE CAMBER**

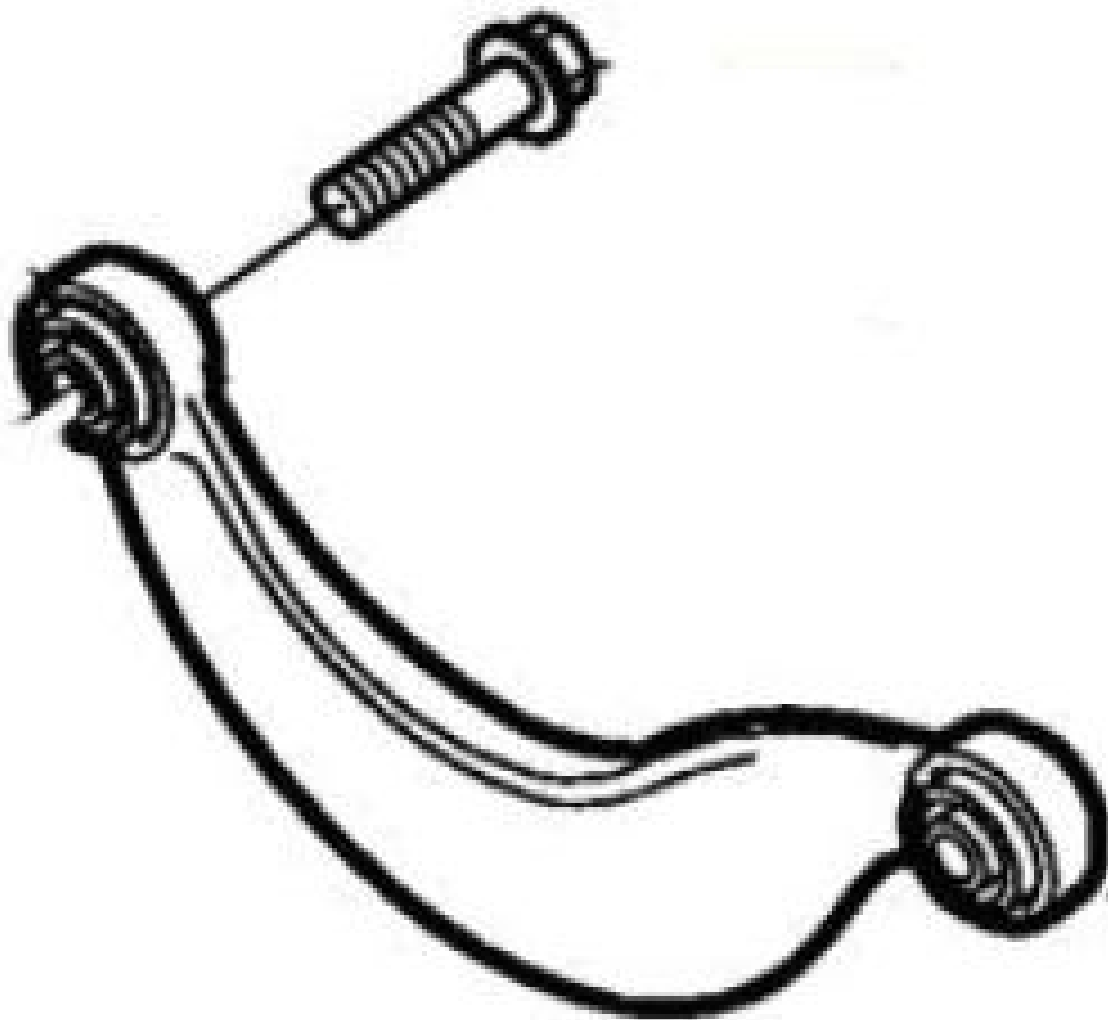
**Photo 1**

A control has been made available as a service part in order to correct excessive rear camber. See Photo 1 below. The control arm has a bushing offset of 2.5 mm (approx 0.1") which will make the camber angle 0.7 degrees less negative. For example, if the camber angle of one rear wheel was initially - 2.6 degrees, it will be -1.9 degrees after the installation of the control arm on that side.
