Installation Guide for 6 cylinder Coil Repair Harness

1999-2006 Volvo 6 cylinder models.

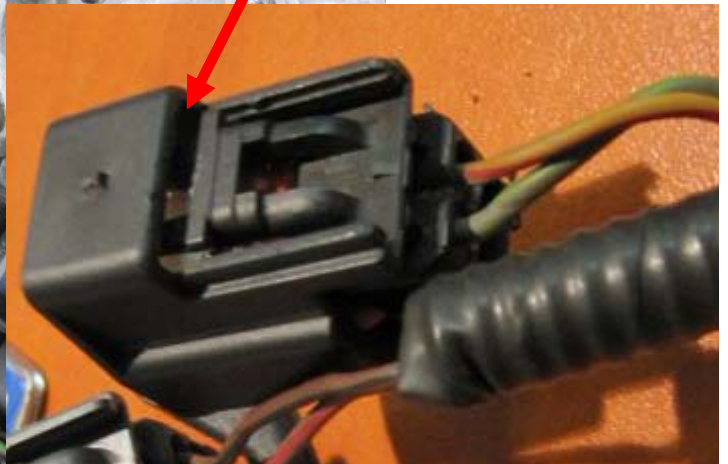
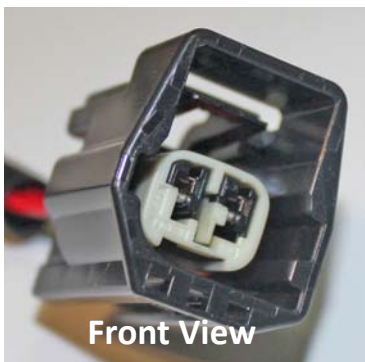
VVT PLUG

Here is the VVT plug in detail.

1. Green/Gray
2. Red/Yellow

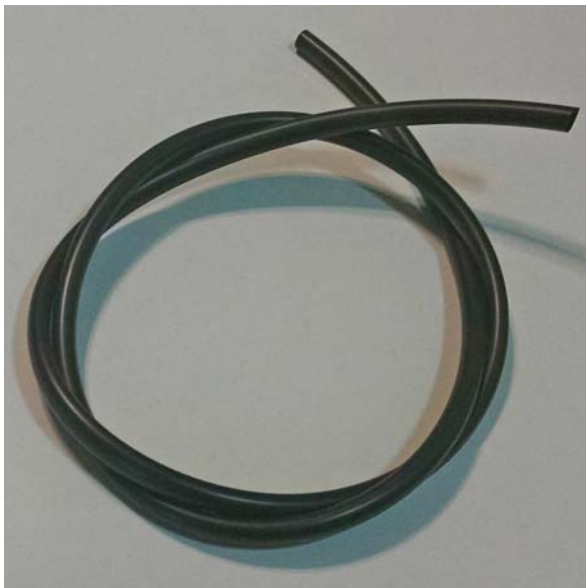
You may reuse your old VVT plugs and wires. You will need to remove the wires from the old wire bundle. This kit includes 3 feet of vinyl harness tubing (1/4 inch diameter) that may be used to protect your old wires.
