700 SERIES & OTHERS - THE VDO (OEM) INSTRUMENT MODULE & SPEEDO By Bob Griffin, United Kingdom (permission granted)

This is a condensed and up-dated version of an article published in the April 2012 Issue of the UK VOC magazine 'Driver', and also here on Dave's website, about the repair of a VDO speedo odometer on a 1990 UK Model 745 (Wagon).

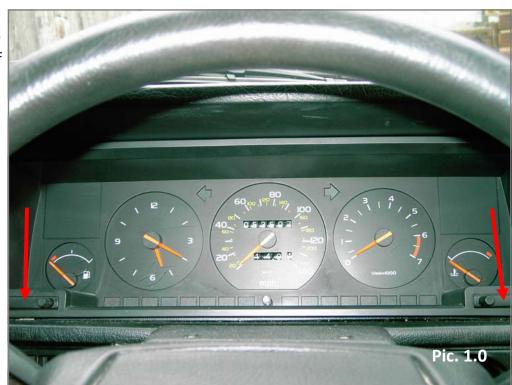
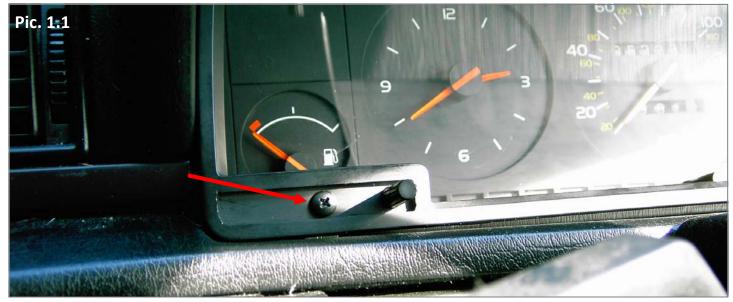
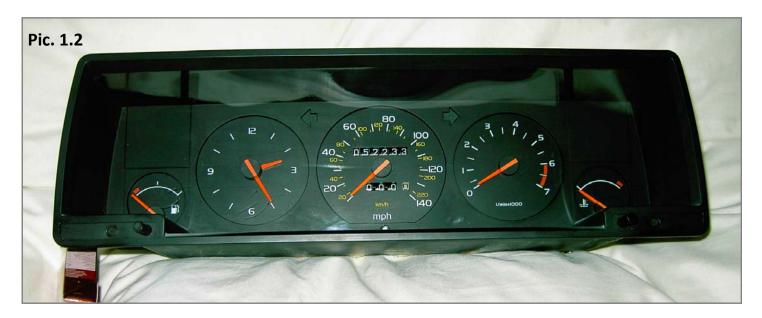
Pics. 1.0 to 1.2 – Remove the cluster module from the car – 2 screws at the base of the cluster left and right underneath plastic 'pop-off' blanks adjacent to the rheostat and clock set buttons.

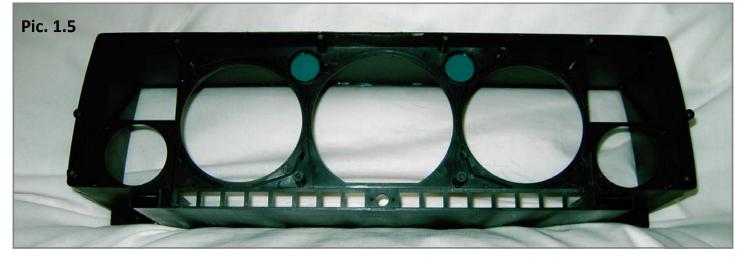
Pics. 1.3 to 1.5 – Separate the two halves of the cluster module – remove 10 screws (3 longer) located more or less around the edge of the white plastic backboard. It

is only necessary to take out one screw from the lighting rheostat; that at the corner of the white backboard.

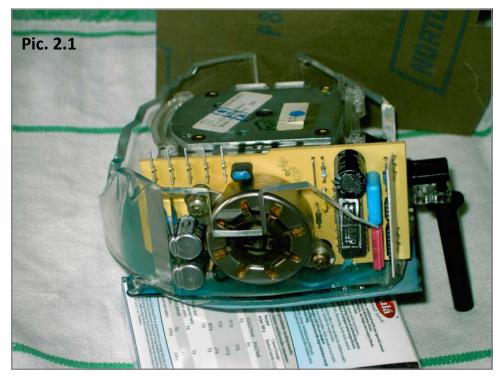
Pics. 2.0 to 2.2 – Gently peel back and pull off the dial face. It is 'soft'

glued to the clear plastic face of the speedo unit. The moulded form of curved clear plastic and 'bluing' serves as a light diffuser to illuminate the dial face from the cluster instrument illumination bulbs.

Do this very slowly and carefully, and have some cling film ('Glad Wrap') ready to place over the two halves when separated to stop any loose small bits on your work surface getting attached to the glue. Take great care to avoid bending the faceplate; it will slowly peel back and off the front of the speedo and the two small plastic location pegs thereon.
