# 1994 940 Relay Locations

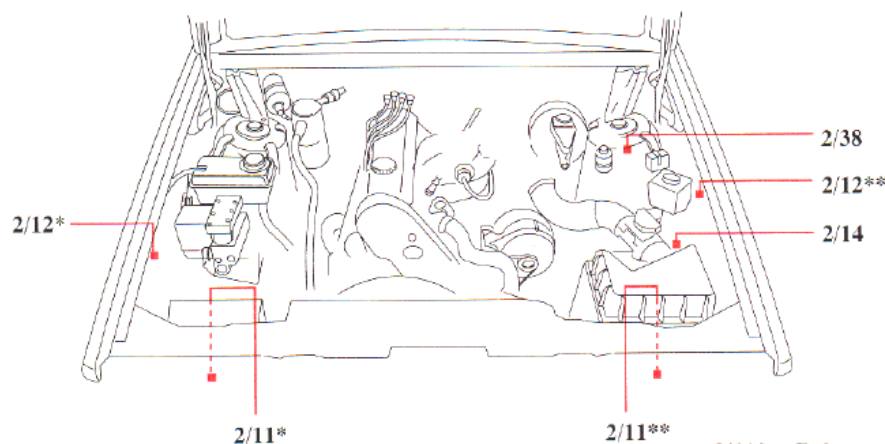
- 2/11\* Relay, engine cooling fan (B 200 F/G, B 230 F/FB/FD/G)
- 2/11\*\* Relay, engine cooling fan (B 200 FT, B 230 FT/GT)
- 2/12\* Relay, interference suppression (B 200 F/G, B 230 F/FB/FD/G)
- 2/12\*\* Relay, interference suppression (B 200 FT, B 230 FT/GT)
- 2/14 Relay, glow plug (D 24 TIC)
- 2/38 Timer relay, exhaust feedback EGR (D 24 TIC)

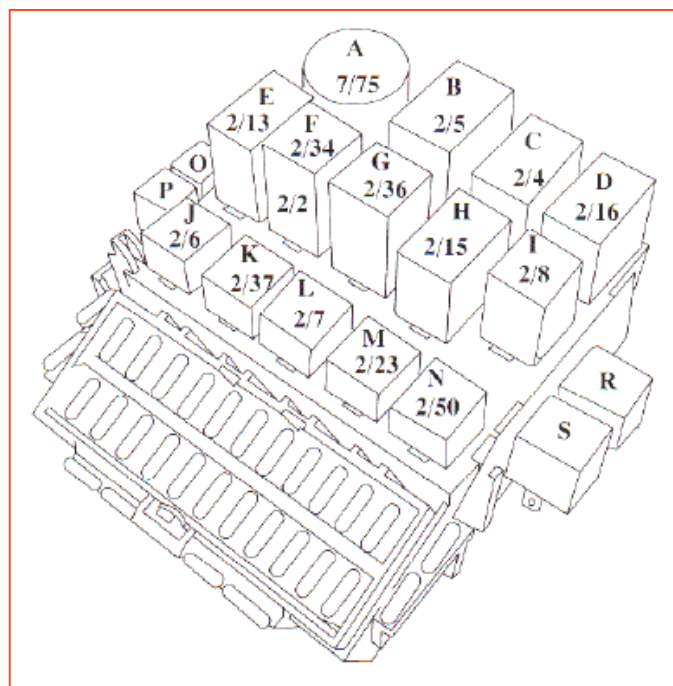
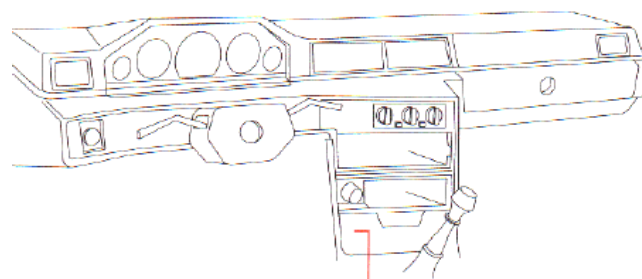
- A Bulb failure warning sensor (7/75)
- B Seat belt reminder/key warning (2/5)  
(USA, Canada, Korea)
- C Windshield wiper intermittent relay (2/4)
- D Tailgate wiper intermittent relay (2/16)
- E Fuel injection (2/13)
- F Foglights, front (2/34 or 2/2 USA, Canada)
- G Headlight flasher (2/36)
- H Exhaust temp. sensor (2/15) (Japan)
- I Overdrive (2/8)
- J Overload relay 15I (2/6)  
(power windows/seat heater)
- K Headlight (2/37)
- L Central lock (2/7)
- M Fuel pump relay (2/23)
- N Overload relay high beam (2/50)  
(not USA, Canada)
- O -
- P -
- R -
- S -
